8.0 ORBITER POST LANDING DEBRIS ASSESSMENT

After the 2:20 a.m. local/eastern time landing on 29 May 2000, a post landing inspection of OV-104 Atlantis was conducted at the Kennedy Space Center on SLF runway 15 and in Orbiter Processing Facility bay 3. This inspection was performed to identify debris impact damage and, if possible, debris sources.

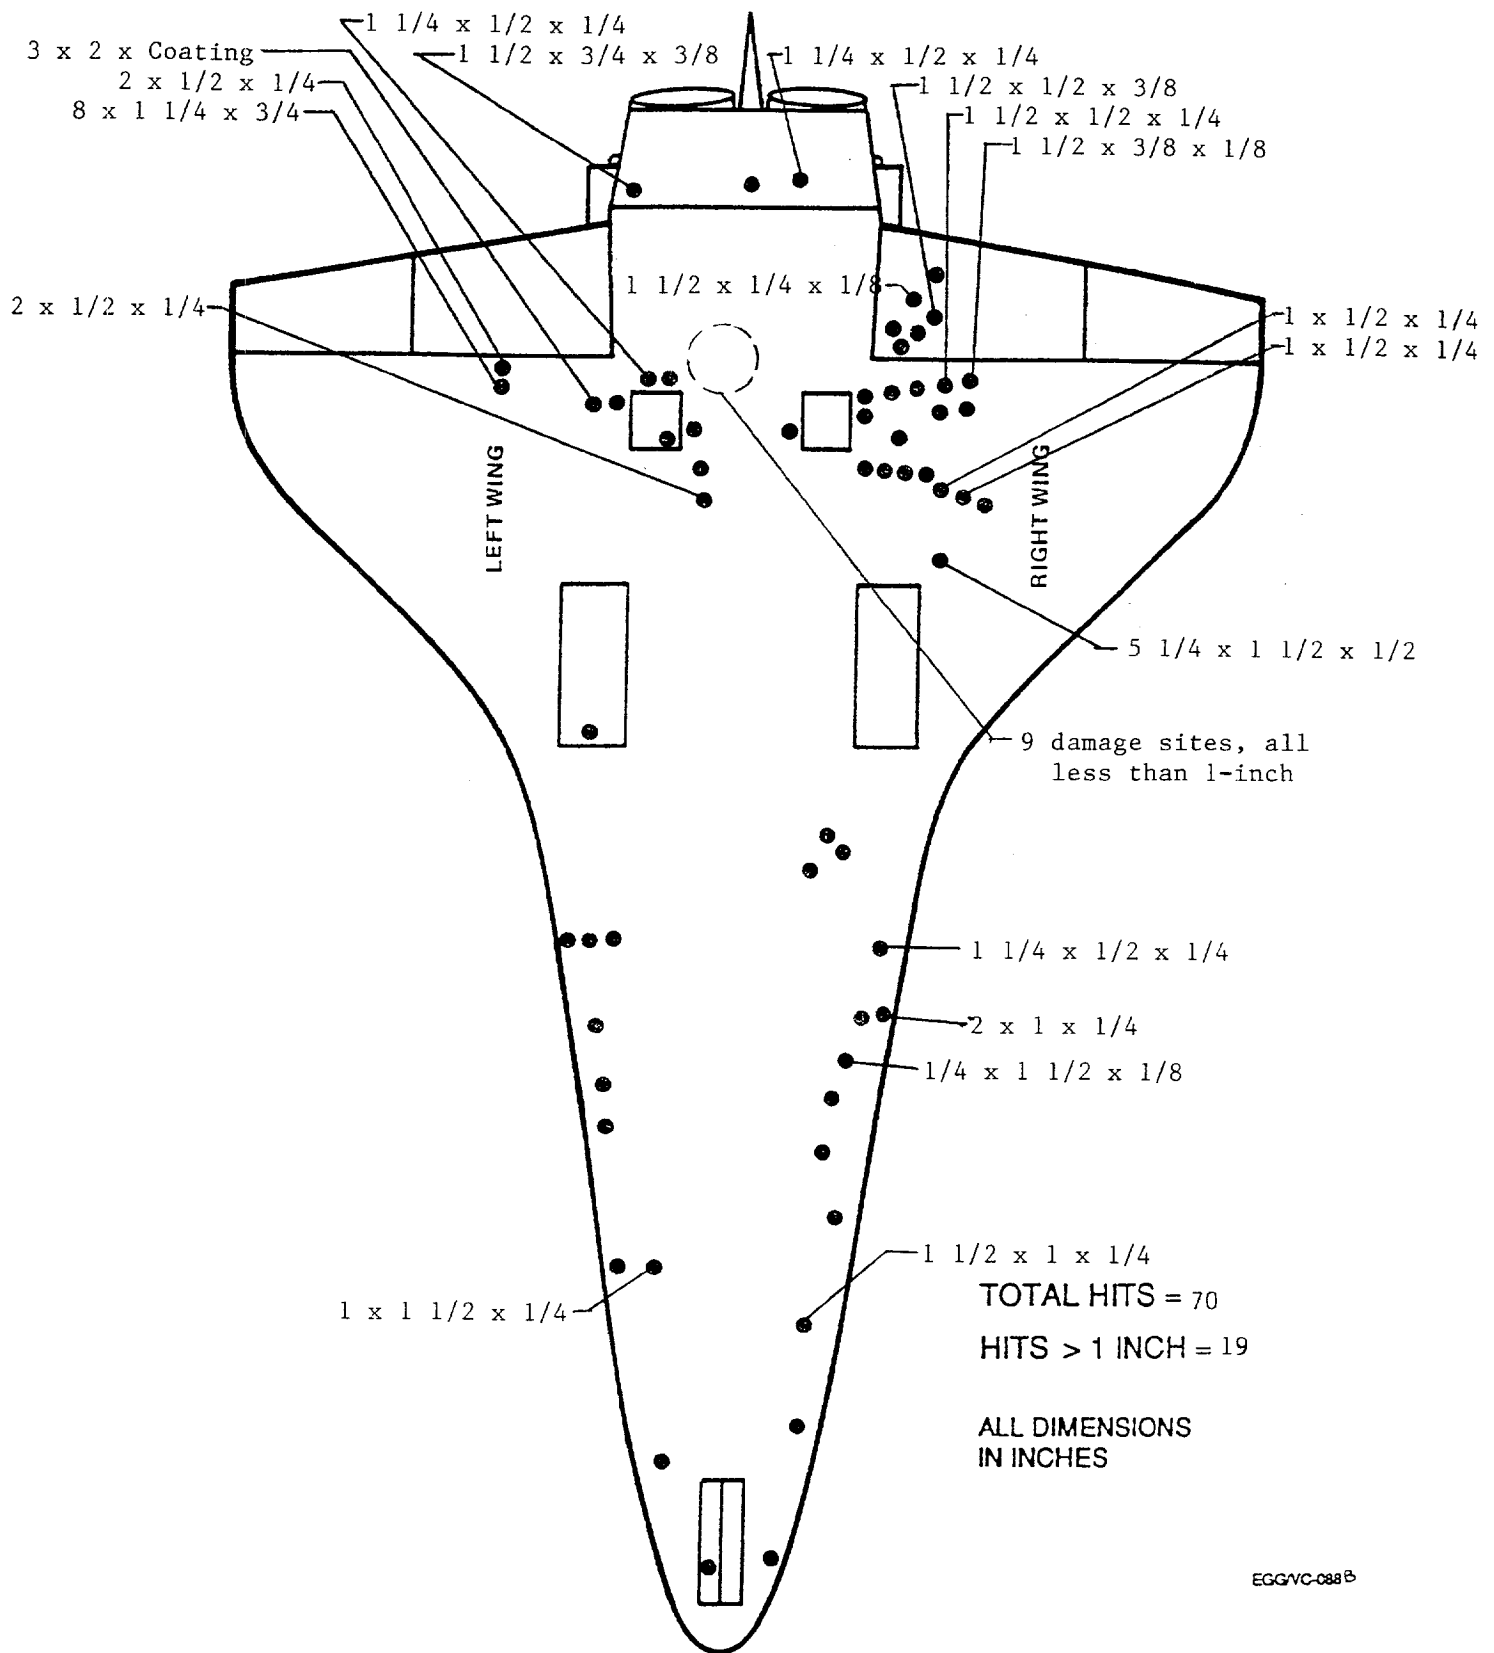
Figure 1: Orbiter Lower Surface Debris Damage Map

The Orbiter lower surface sustained 70 total hits, of which 19 had a major dimension of 1-inch or larger. Some of these damage sites (23 hits with 5 larger than 1-inch) were located in the area from the nose gear to the main landing gear wheel wells on both left and right chines, which is consistent with the loss of foam from the ET thrust panels. But the overall quantity and average size of the damage sites compared to previous flights were consequently reduced as a result of the pre-launch TPS venting modification. And some of the hits in this area may also be attributed to impacts from LO2 feedline bellows ice particles.

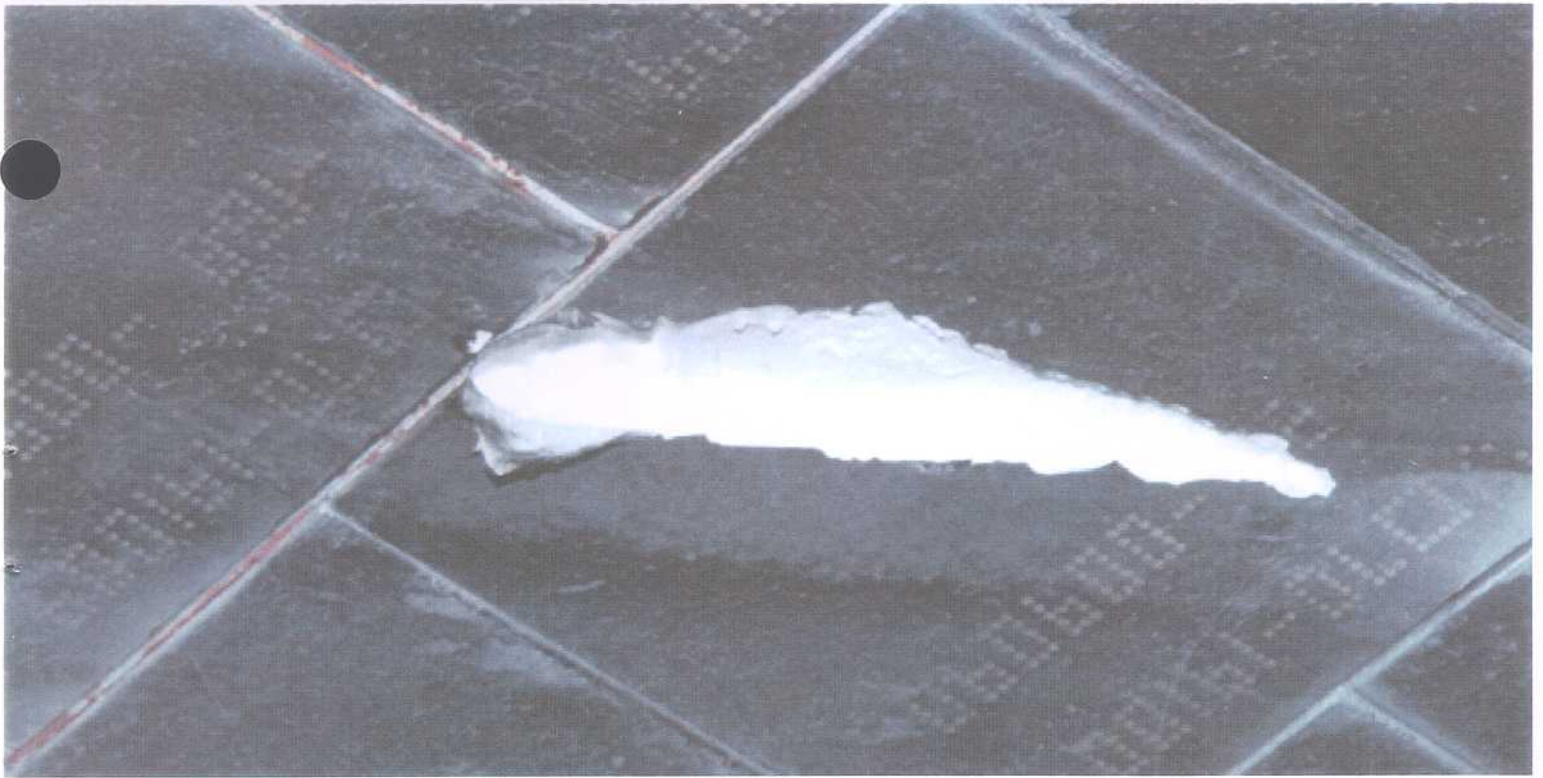
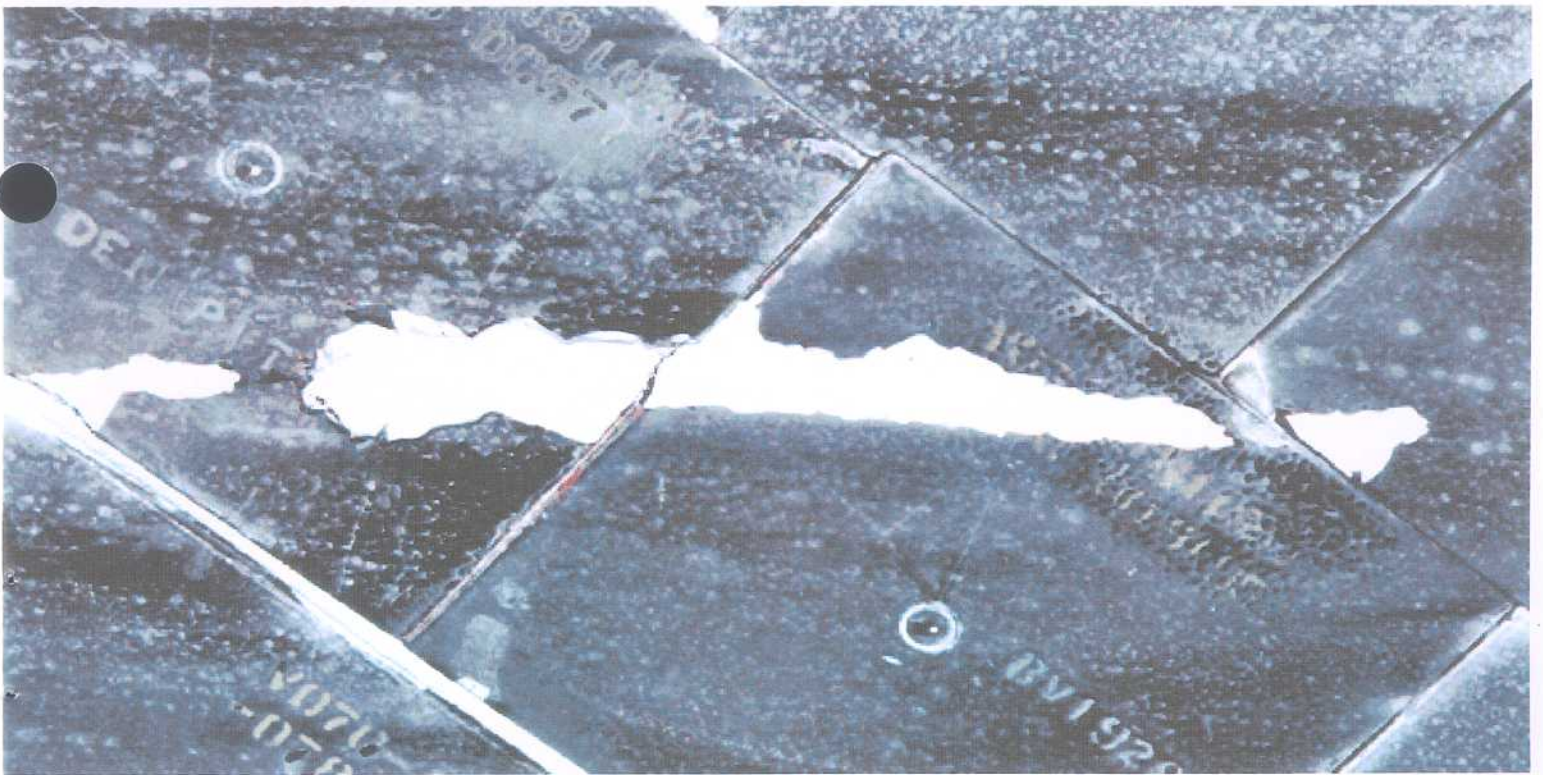
Photo 30: Damage to Lower Surface Tiles

The largest lower surface tile damage site, located on the left wing immediately forward of the inboard elevon hinge, measured 8-inches long by 1.25-inches wide by 0.75-inches deep. The cause of this damage site has not been determined. However, it should be noted the damage site typically erodes during re-entry and may have initially been half the size listed above. Referencing the Debris Trajectory Database showed potential points of origin on the forward and mid segments of the left SRB, so it is possible a small, high density particle, such as a piece of cork or BTA may have come loose in flight.

Likewise, a lower surface tile (V070-191009-161) damage site on the right wing, approximately 10 feet forward of the right inboard elevon hinge, corresponded to the debris object impact detected in launch film E-224. The damage site measured 5.25-inches long by 1.5-inches wide by 0.5-inches deep, though re-entry erosion had enlarged this damage site as well. Due to the “gouge like” appearance and depth, this damage site was caused by a debris object with a greater density than ET foam, such as ice from the ET LO2 feedline bellows. Several tile hits aft of this location may have been the result of secondary impacts.

Again referencing the Debris Trajectory Database, Boeing analysts found 10 cases having impact locations closest to the actual impact location for the two Mach Numbers 0.60 and 1.05 closest to the actual flight Mach Number of 0.75. The majority of the closest cases corresponded to the density of ice (30-57 pcf). Therefore, the most likely source of the ice debris was the ET LO2 feedline upper bellows. The composition of the “vaporous streak” detected in the launch films was a mixture of ice debris and damaged tile material particles.

Top photo shows a damage site on the lower surface of the right wing approx. 10 feet forward of the right inboard elevon hinge. This corresponded to the ice impact detected in launch films. The damage site measured 5.25-inches long by 1.5-inches wide by 0.5-inches deep, though re-entry erosion had enlarged this damage site. Bottom photo shows the largest lower surface tile damage site. It was located on the left wing immediately forward of the inboard elevon hinge and measured 8-inches long by 1.25-inches wide by 0.75-inches deep. The cause of this damage site has not been determined.

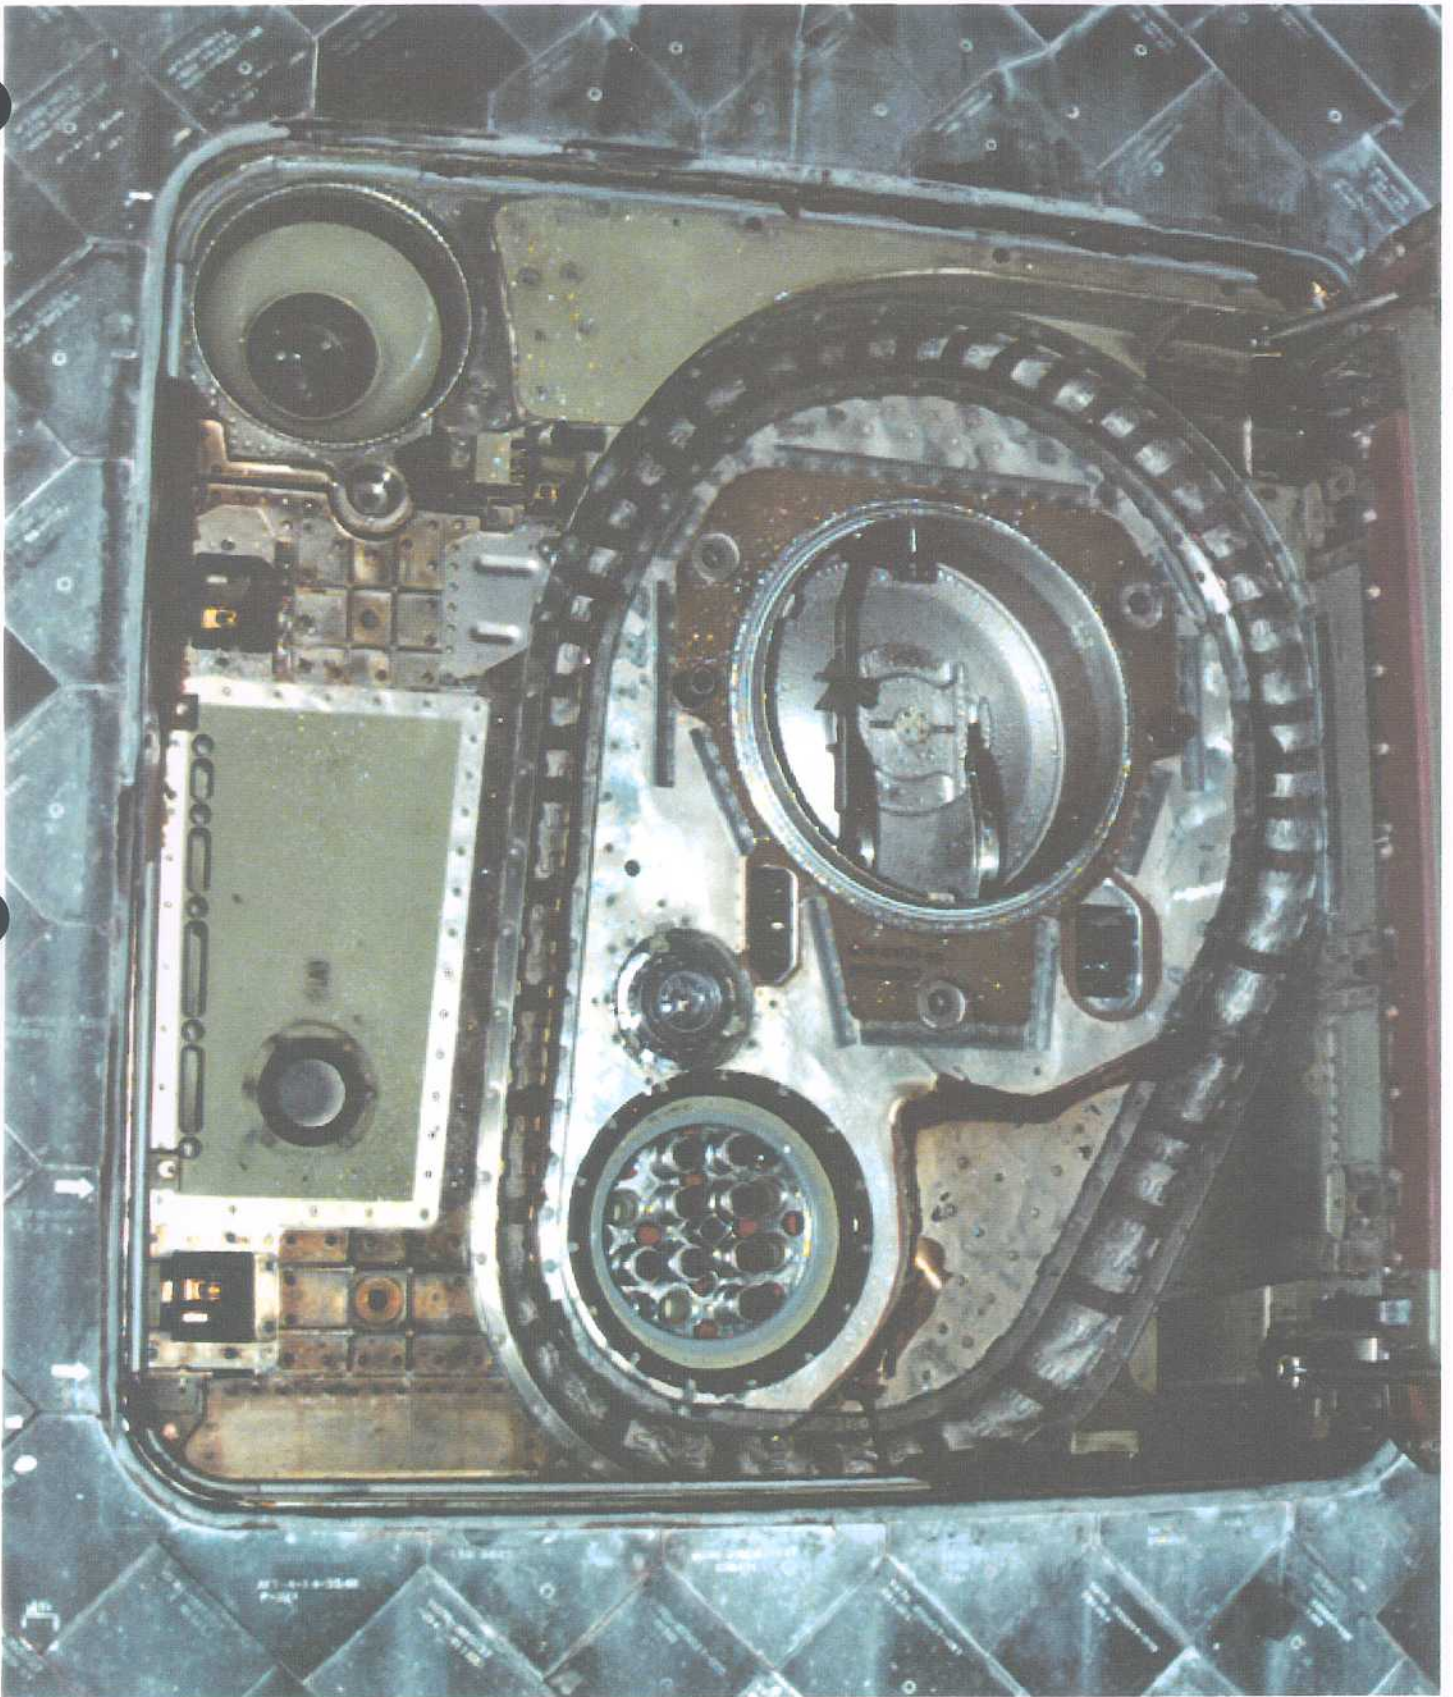
Photo 31: LO2 ET/ORB Umbilical

Numerous tile hits around the ET/ORB umbilicals were attributed to impacts from umbilical ice or shredded pieces of umbilical purge barrier material flapping in the airstream.

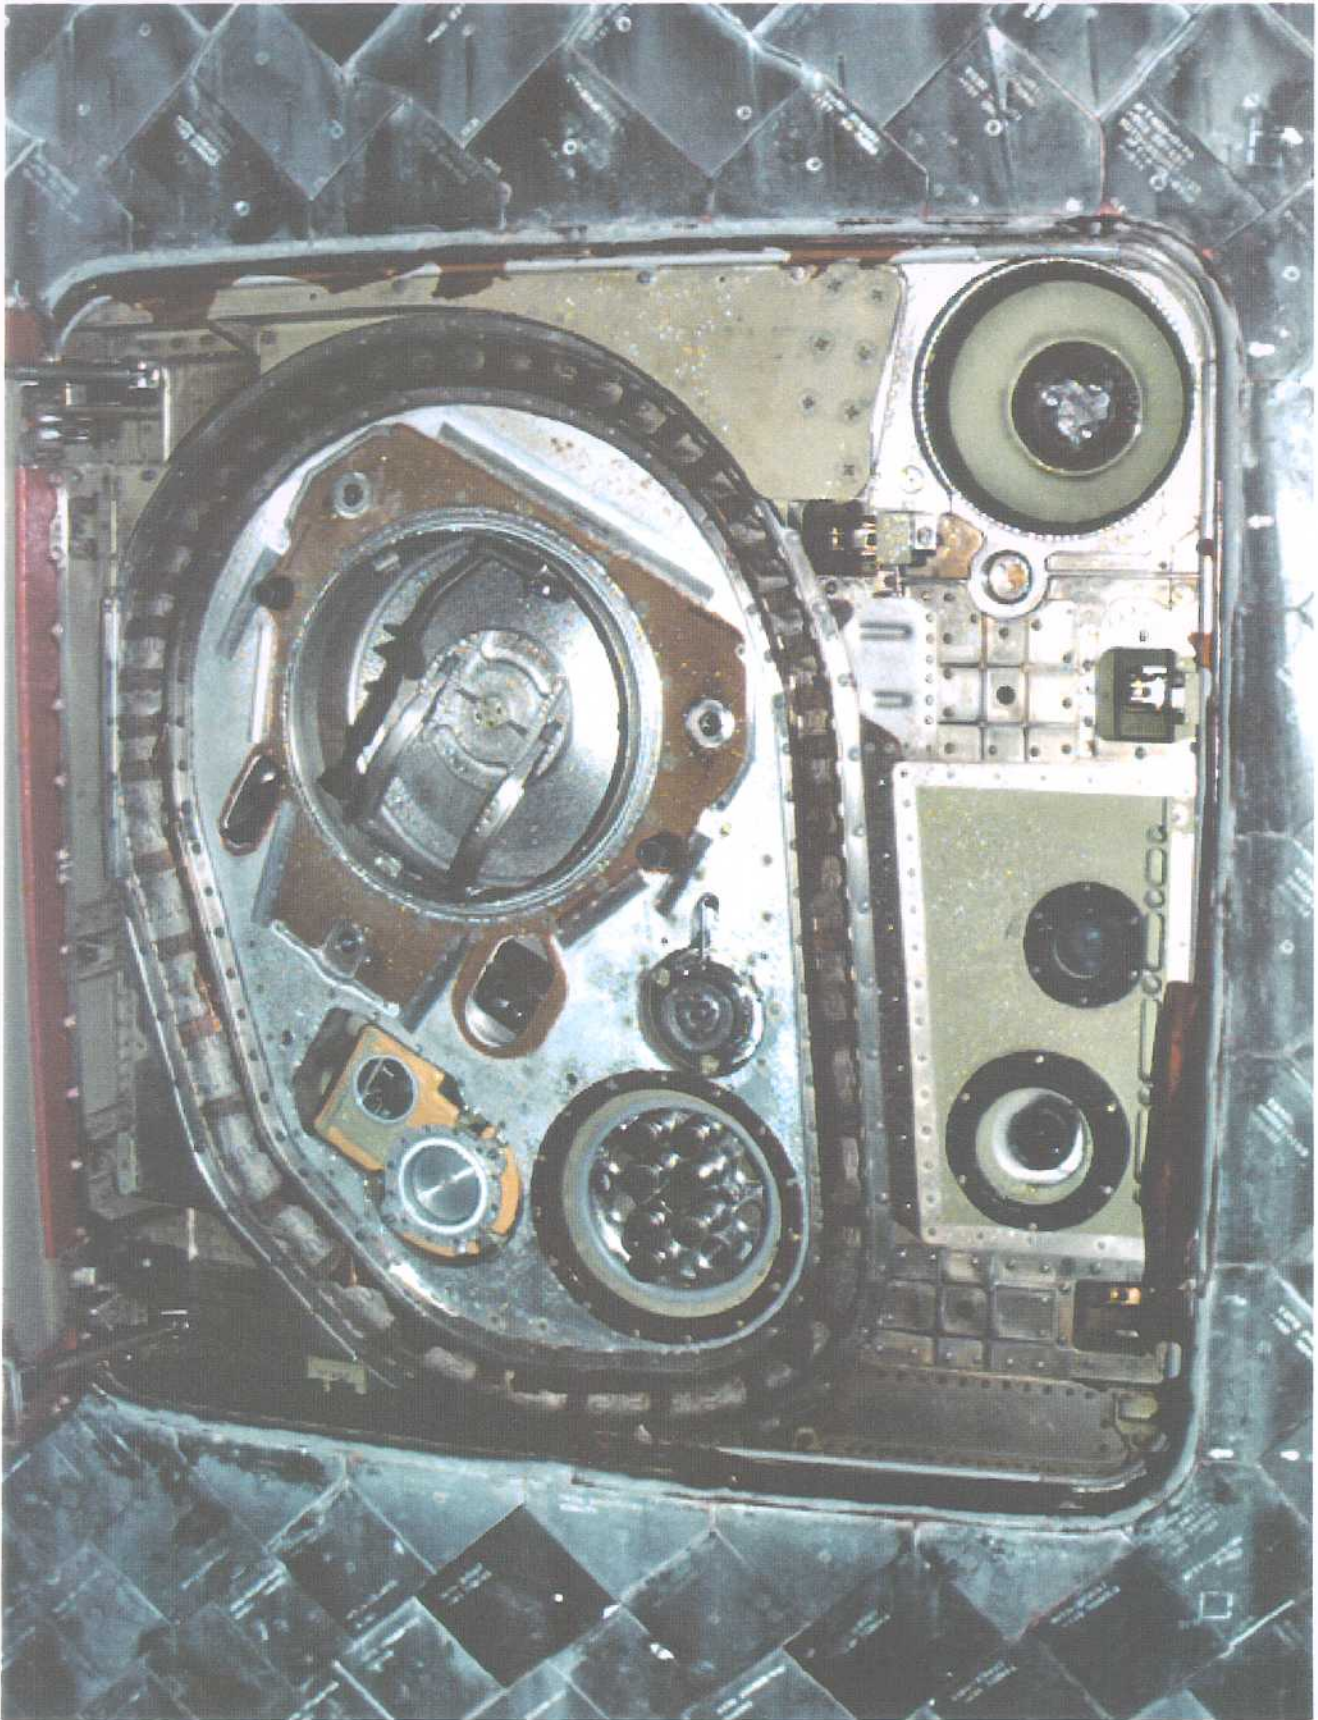
Photo 32: LH2 ET/ORB Umbilical

ET/Orbiter separation devices EO-1, EO-2, and EO-3 functioned normally. No ordnance fragments were found on the runway beneath the umbilicals. The EO-2 and EO-3 fitting retainer springs appeared to be in nominal configuration, though two of the EO-2 “salad bowl” clips were missing. No umbilical closeout foam or white RTV dam material adhered to the umbilical plate near the LH2 recirculation line disconnect.

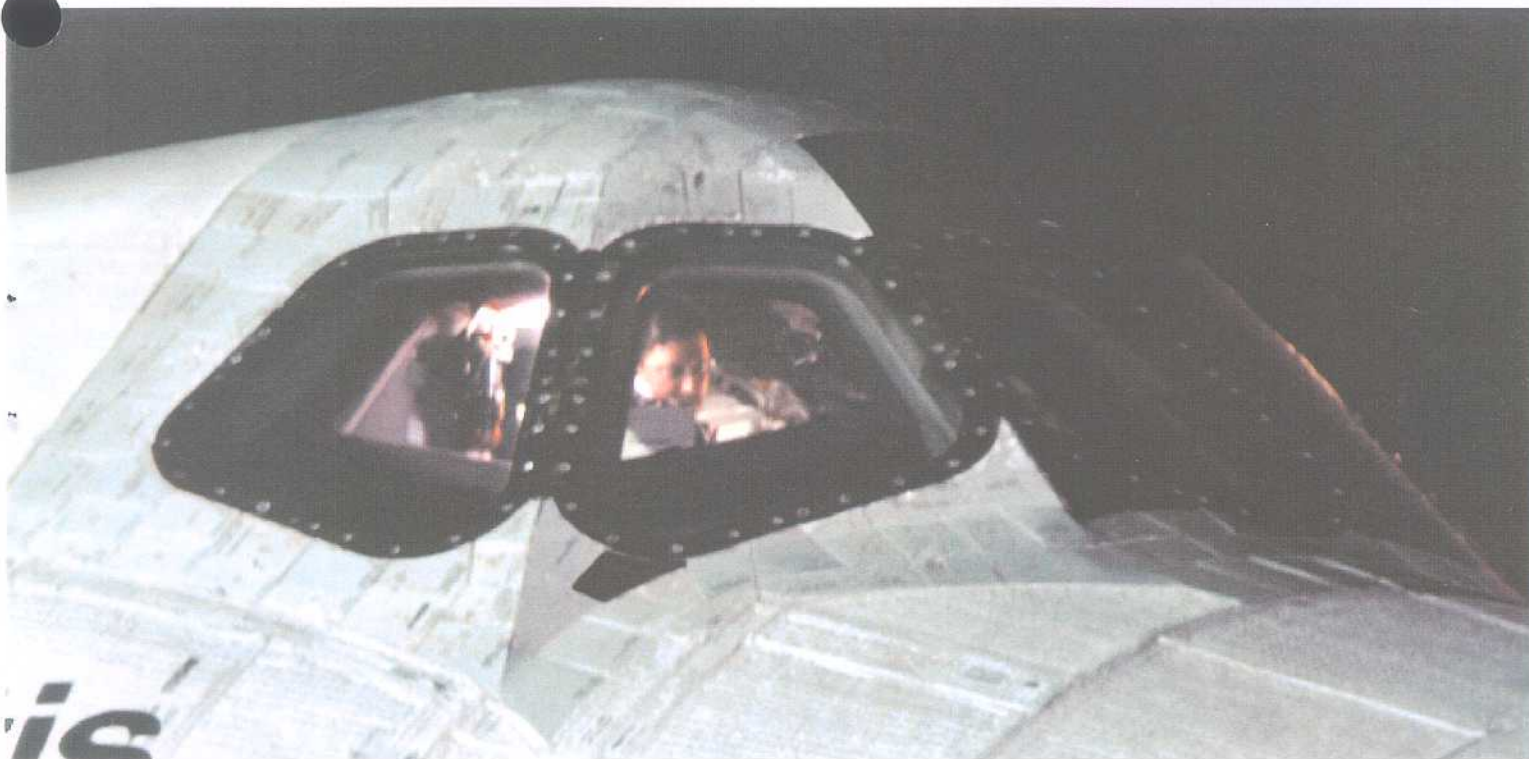
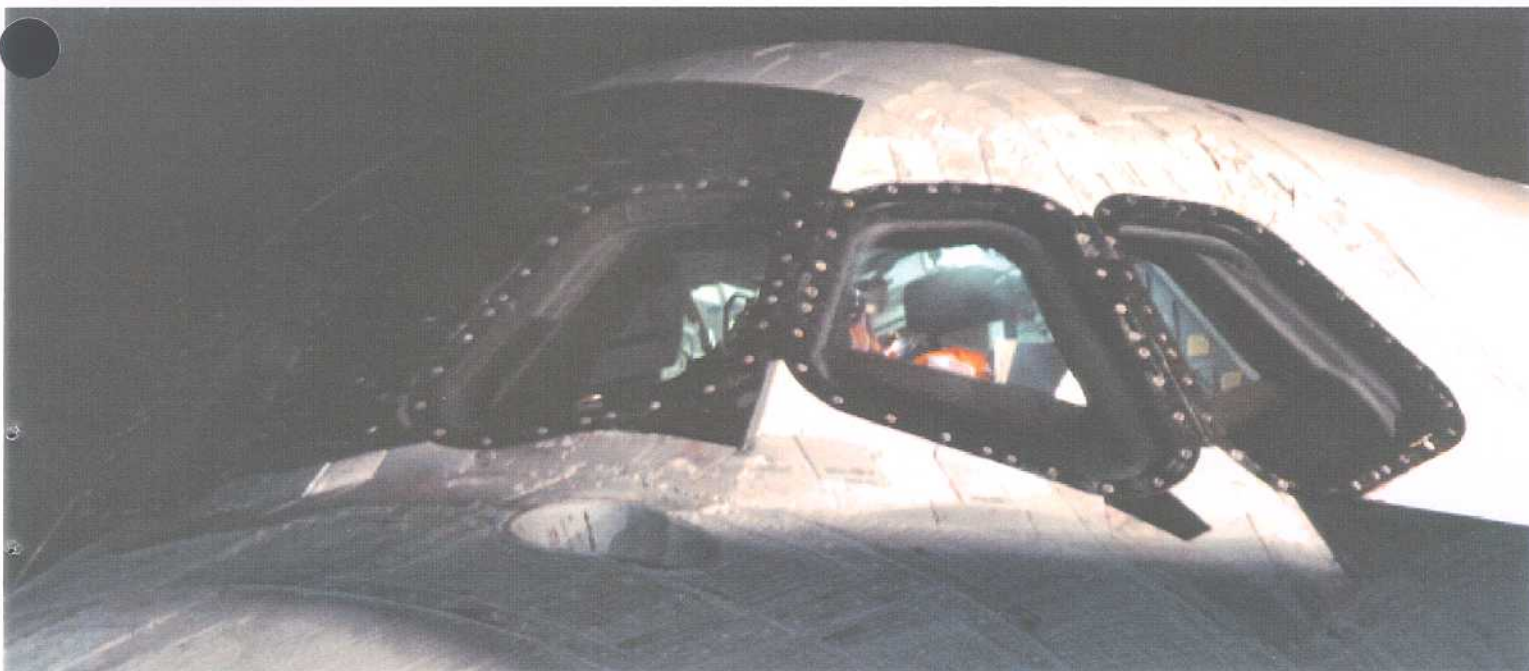
Photo 33: Windows

Damage sites on the window perimeter tiles was less than usual in quantity and size. Hazing and streaking of forward-facing Orbiter windows was moderate. The largest damage site, located in window #2 perimeter tiles, was approximately 1.5-inches long by 0.75-inches wide. This damage may be attributed to impacts from FRCS thruster paper covers and RTV adhesive.
